Two-and three-dimensional hydraulic modeling of innovative grade control structures project at Millbrook Exchange Park

April 2021

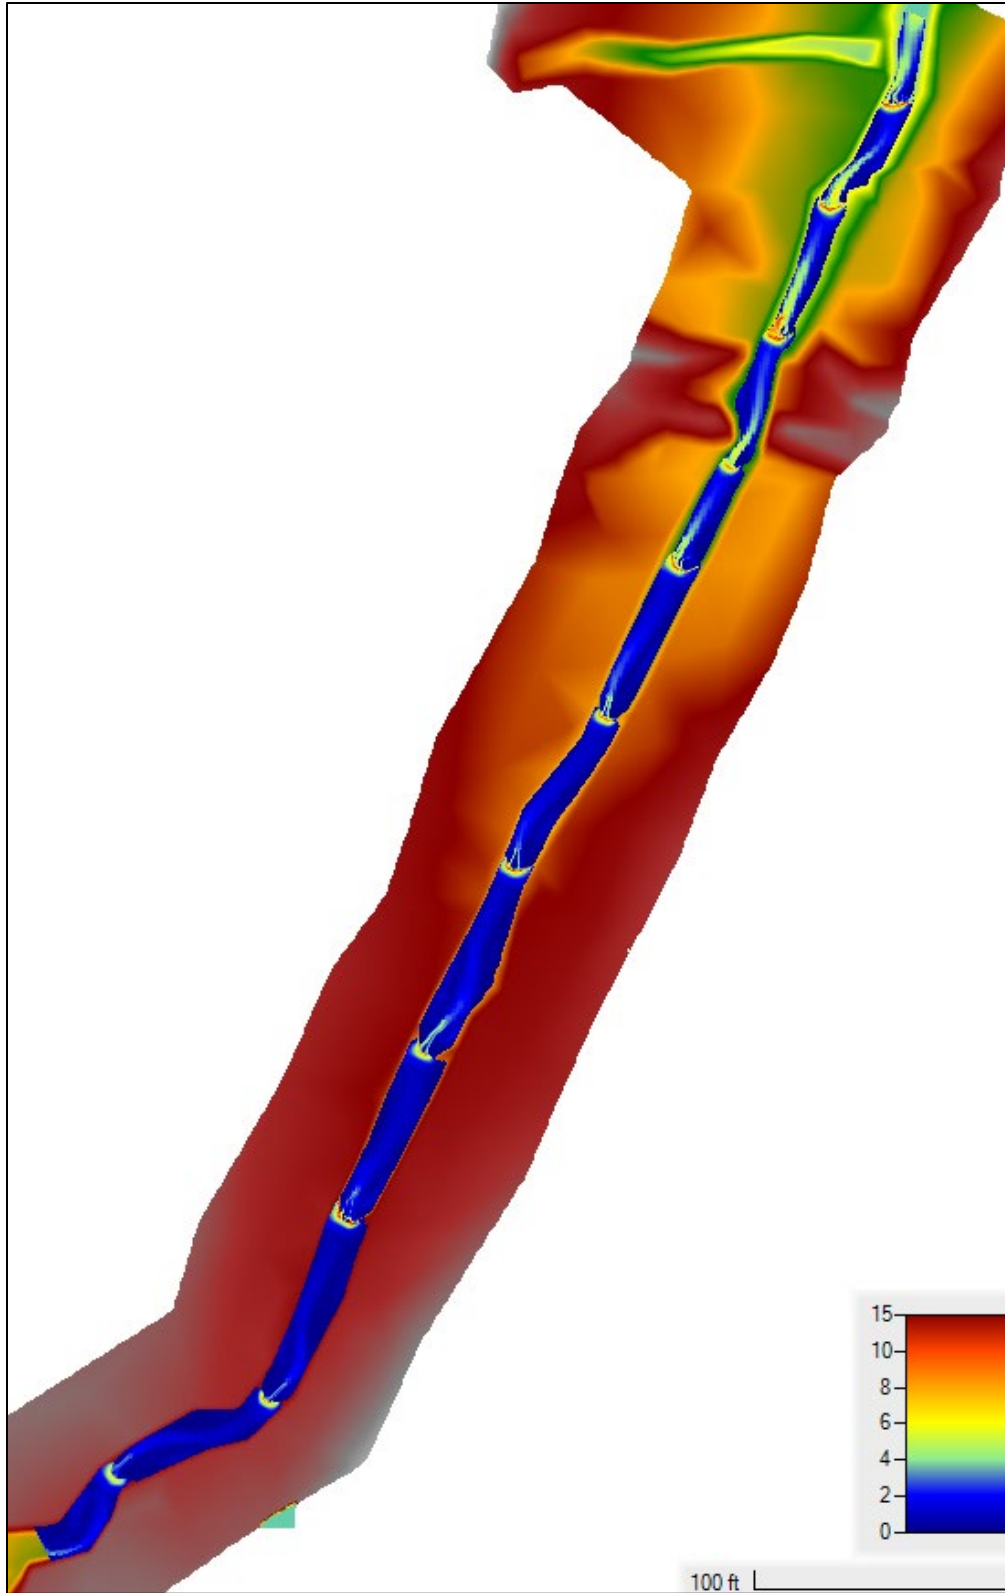
The velocity distributions for the 1-, 2-, and 5-year events are shown in Figure 3 through Figure 5. For the 1-year event the stream velocity in the channel was mostly below 2 ft/s, with the exception of areas at and just downstream of the boulder structures. The channel velocity increased to around 3-5 ft/s in the lower end of the project reach as the channel slope is much steeper in this area.

Figure 3. Quasi steady-state maximum velocity for the 1-yr event.

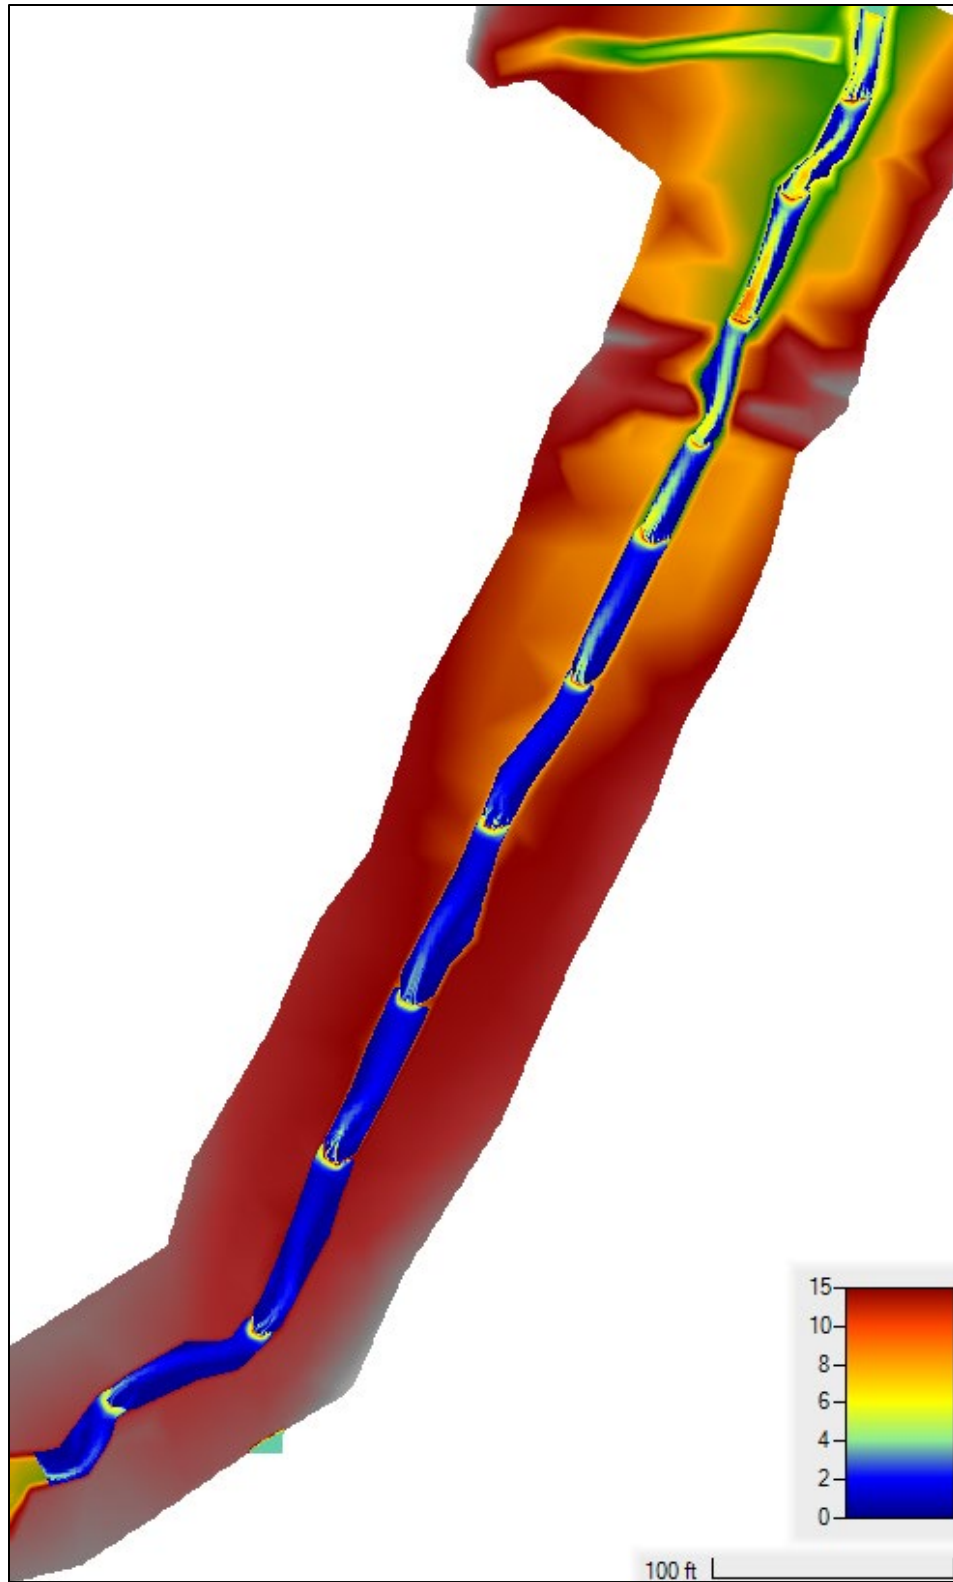
The 2- and 5-yr velocity distributions also show a similar pattern with higher velocity at and just downstream of the structures and low to moderate velocity in the upper half of the reach. The velocity increased in the lower half of the project reach, exceeding 10 ft/s for the 5-yr storm (Figure 6 and Figure 7).

Figure 4. Quasi steady-state maximum velocity for the 2-yr event.

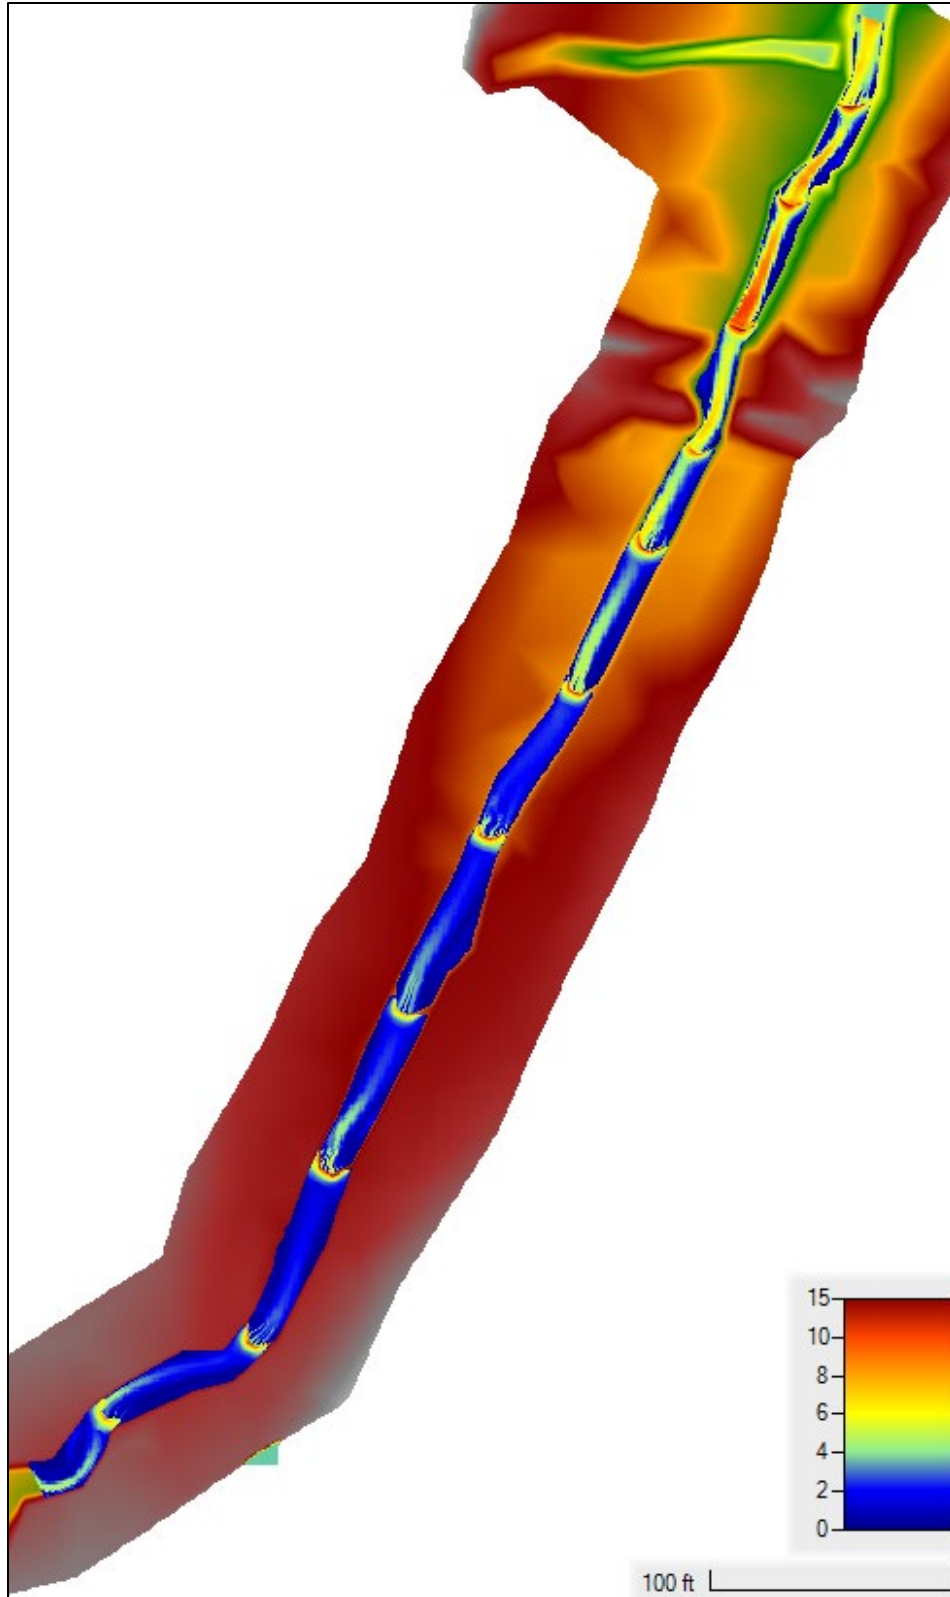
Figure 5. Quasi steady-state maximum velocity for the 5-yr event.

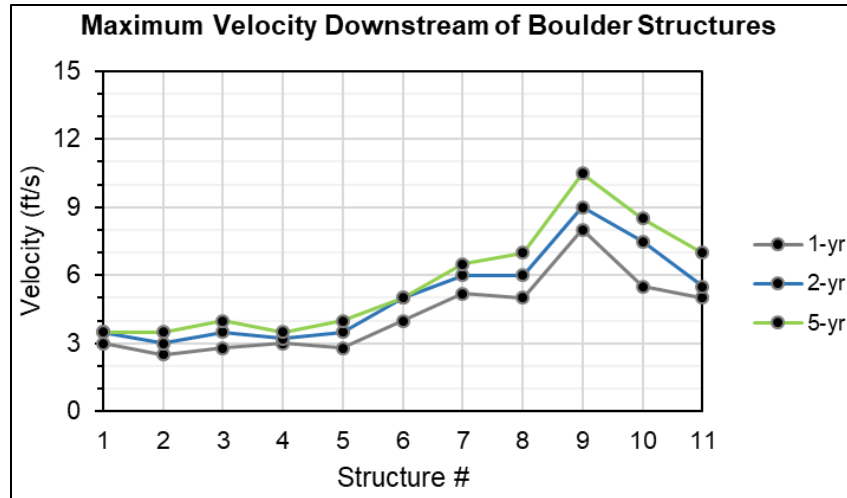
Figure 6. Quasi steady-state maximum velocity downstream of boulder structures.

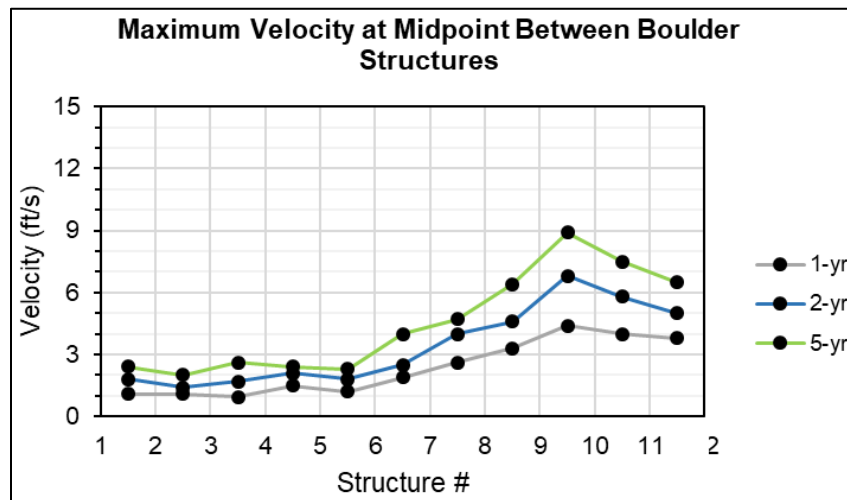
Figure 7. Quasi steady-state maximum velocity at midpoint between boulder structures.

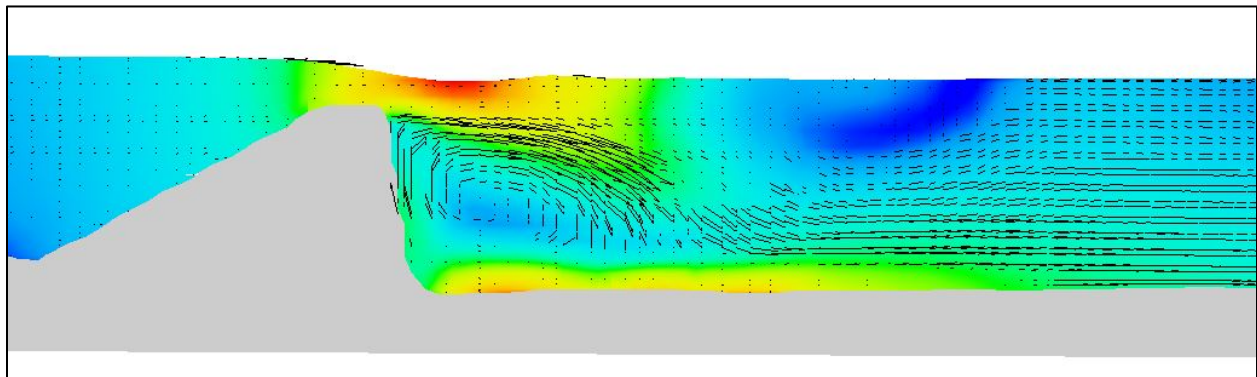
Three-dimensional modeling showed that the change in elevation downstream of each structure created recirculating, turbulent flow paths (Figure 8). These results suggest that even where low depth-averaged velocity is indicated downstream of structures, hydraulic conditions that would prevent sediment accumulation may still occur.

Figure 8. Quasi steady-state maximum velocity profile at structure 1 for the 2-yr discharge.

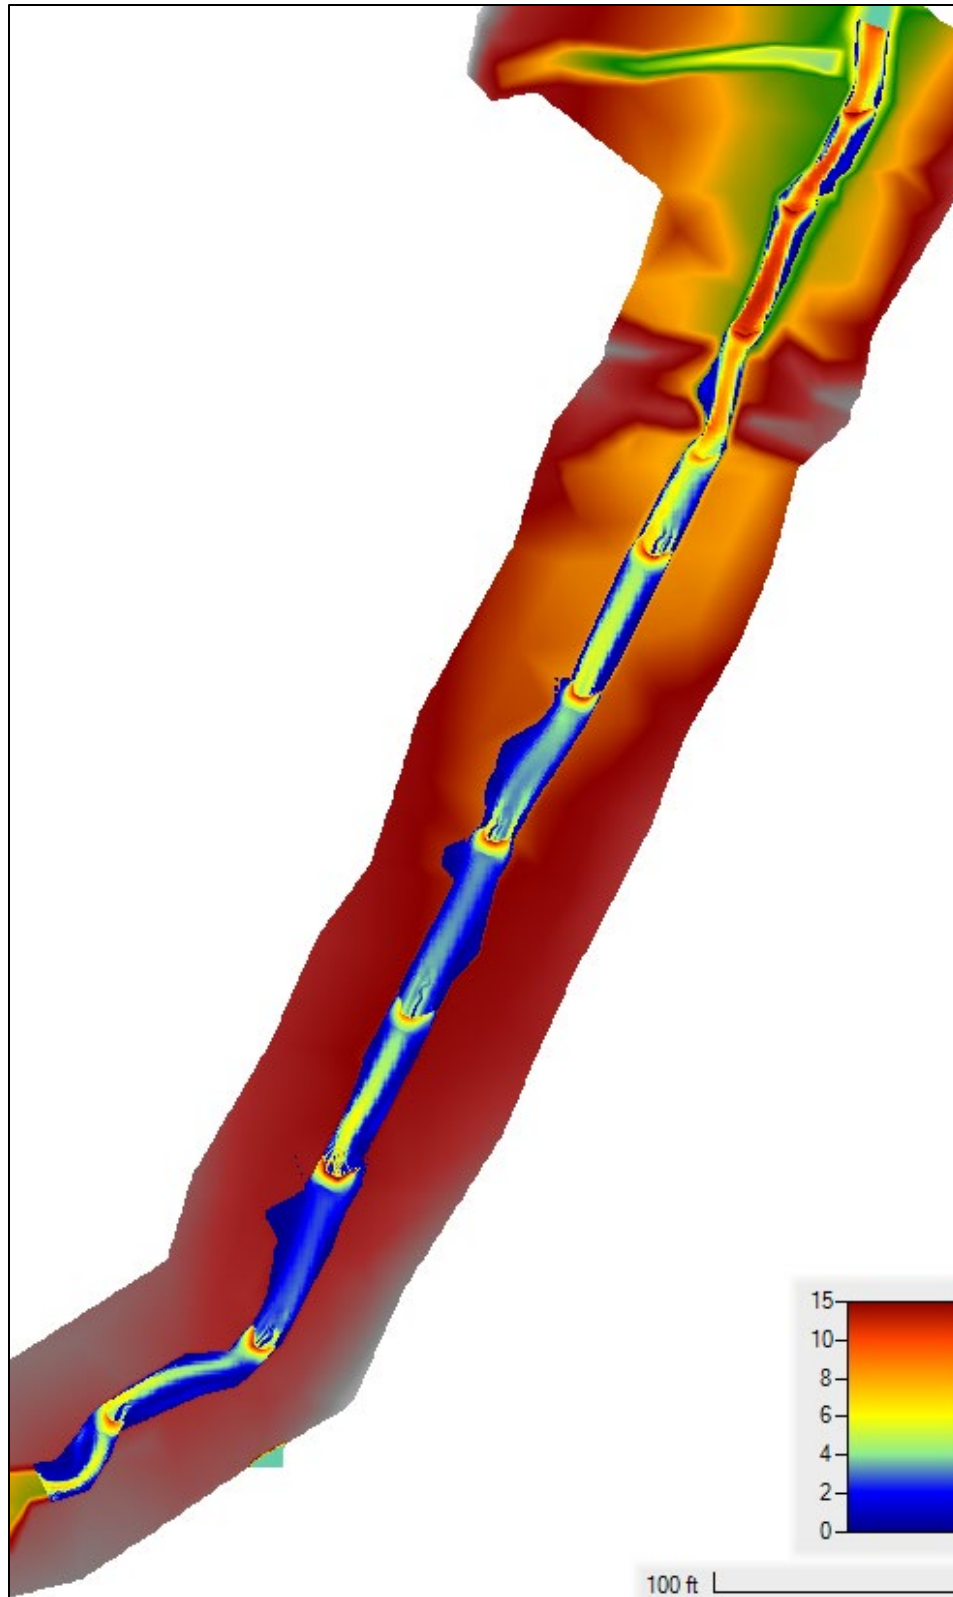
While repeated sub-5-year peak discharge events caused several failures of the boulder structures and substantial erosion on the downstream side of the structures, particularly in the lower end of the project, model results indicate that larger storms pose an even greater risk. For events in excess of the 25-yr storm, the streamflow will be confined to the channel (Figure 9). The 100-yr event peak discharge will produce very limited overbank flow (depth < 0.3 ft.) in the upper half of the project reach, but the flow will remain confined to the channel for the lower half of the project reach (Figure 10). This lack of floodplain connection and confinement of flow to the channel will result in even higher velocity and shear that will further stress the structures and channel (Figure 11).

Figure 9. Quasi steady-state maximum velocity for the 25-yr event.

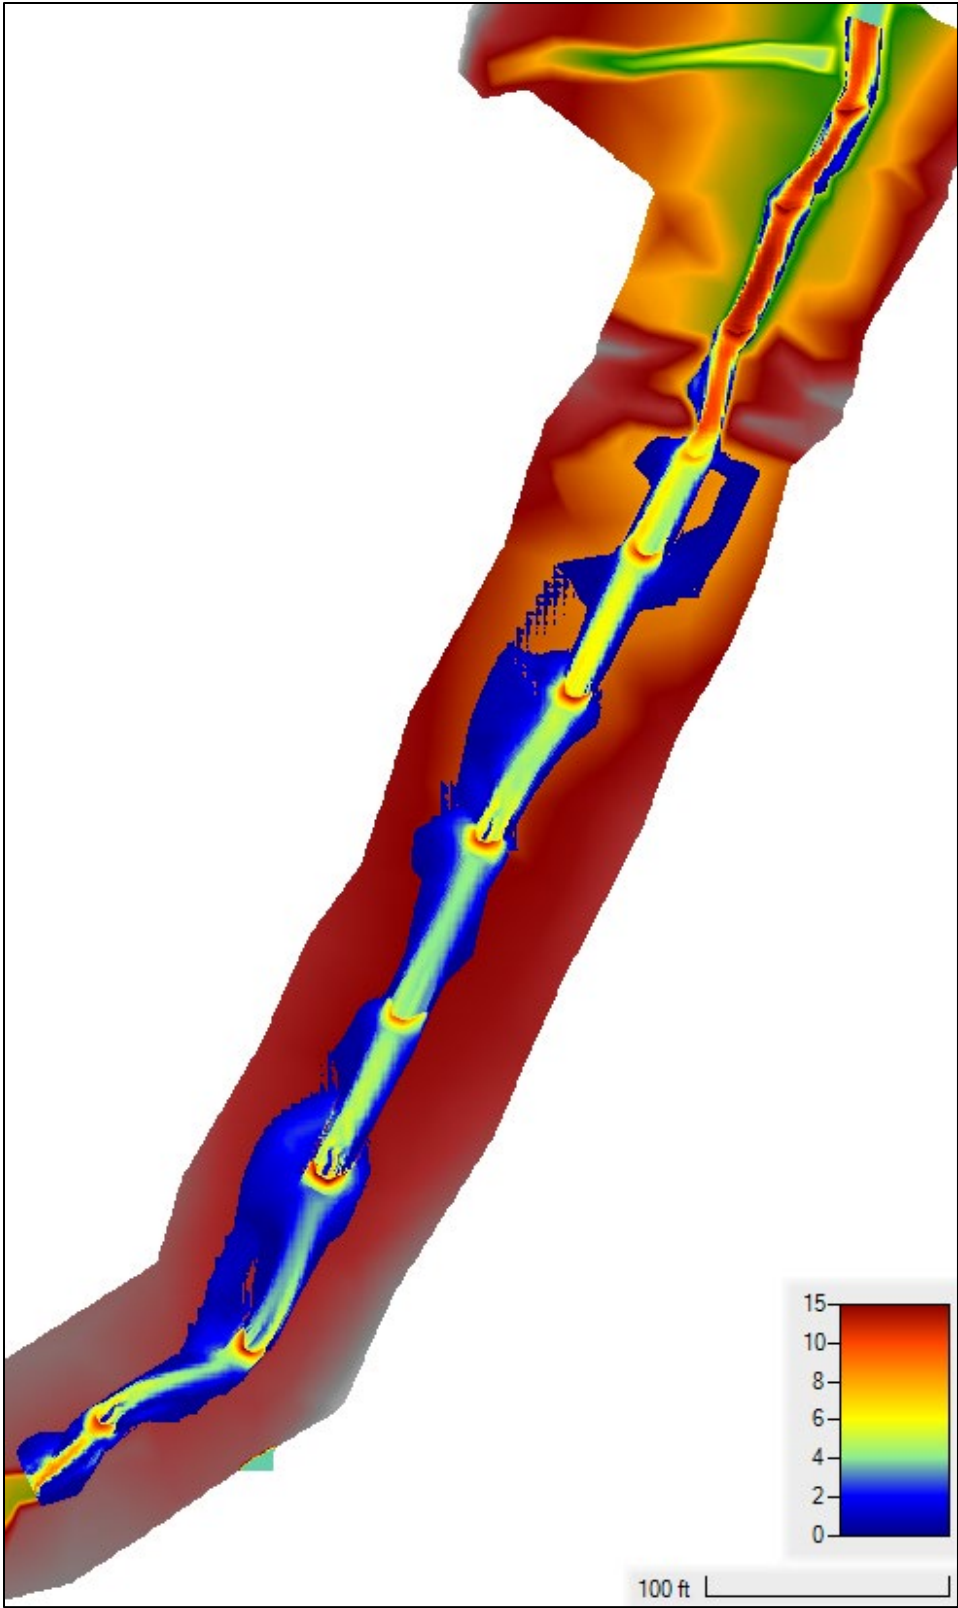
Figure 10. Quasi steady-state maximum velocity for the 100-yr event.

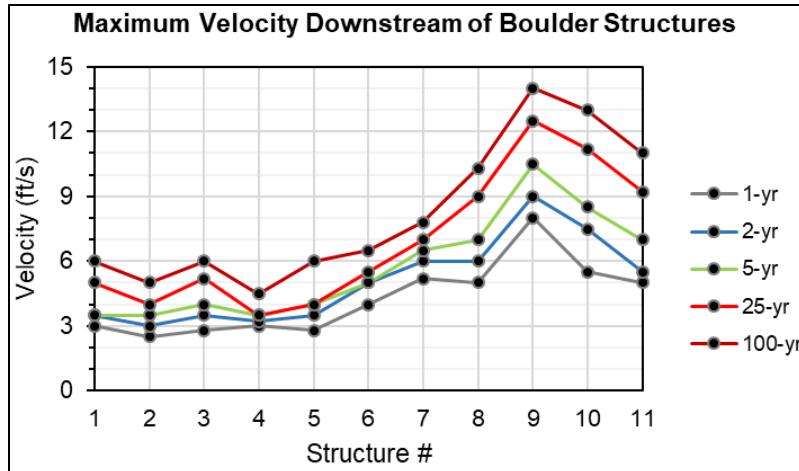
Figure 11. Quasi steady-state maximum velocity downstream of boulder grade control structures.
